# Minutes and record of site inspection meeting between RBG and Residents of the Vanbrugh Park Estate 1/06/23.

### The Undercroft:

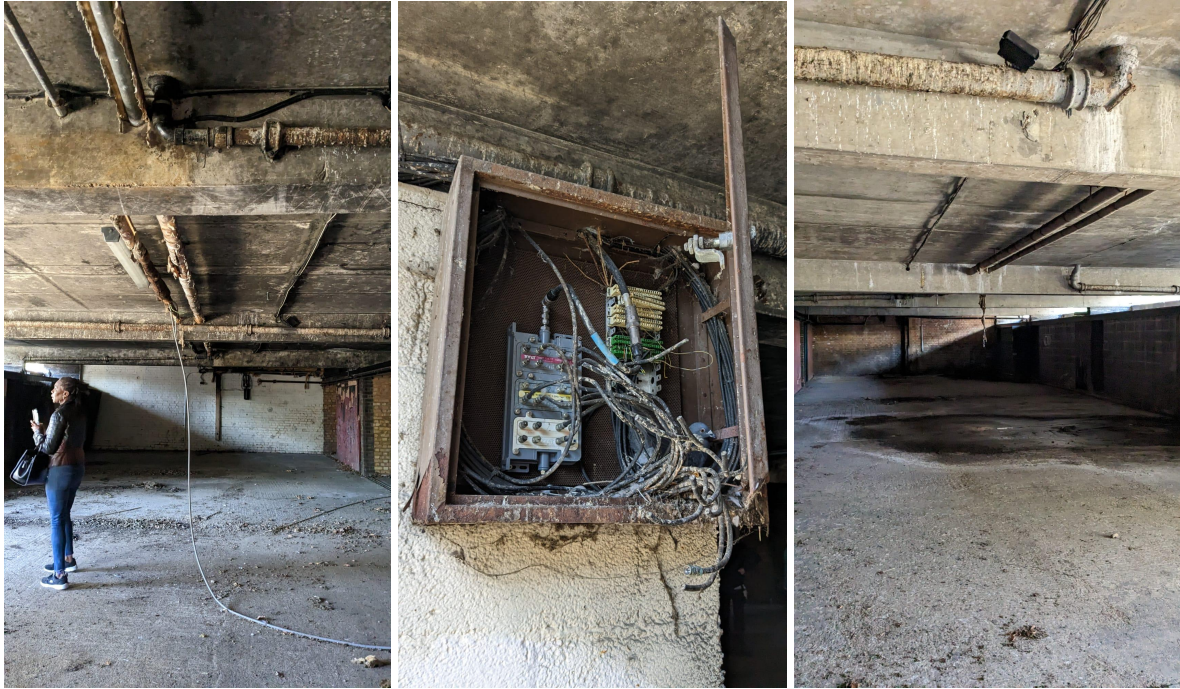
*Above: the Undercroft beneath Combe Mews. Multiple health hazards from vermin, leaks, structural and electrical issues. Pigeon nesting in an open coaxial cable box. Leak below flat 3.*

The tour started in the undercroft, a huge gated unused area containing empty garages and sheds, which was identified as having significant health and safety issues that impact residents in the Combe Mews flats above. The undercroft has been closed for many years and shows many signs of neglect. Photos attached to this document illustrate the scale of both the space and its problems. There are mounds of pigeon droppings (see attached document about the diseases spread by pigeon droppings), pigeons are able to easily access the undercroft and nest there. There are also rats and mice living in the space and the mesh gates do not stop dried droppings blowing around the wider area.

A waste pipe from flat 3 has been overflowing onto the floor since at least 1997, this has been reported innumerable times to no effect and the smell pervades the flats above and the roadway outside causing distress to residents. Pipes running along the ceiling are rotten, covered in pigeon droppings and with lagging hanging down.

Exposed electricity, phone and internet cables run outside and inside the undercroft in an ad-hoc manner, often exposed to vermin and the elements, the main electricity fuse box and associated cabling were behind an open door. The soffit of the entire space is scorched and filthy – evidence of a fire from many years ago on the east side of the space, is still evident – and often damp. The disused garages have wooden doors which would be readily available fuel in the event of fire.

**Exterior:** as a result of persistent damp and unresolved subsidence issues the entire block is at risk of becoming structurally unsound. Block work is eroding in many places. Subsidence is affecting the staircase adjacent to Vanbrugh Park Road and in consequence the whole of 1-19 Combe Mews.

**Action:** - the whole of the undercroft should be cleaned, the vermin eradicated, all cabling checked and made safe, pipes and lagging replaced and the leak from flat 3 finally fixed at the first possible opportunity and further investigations as to the damage caused. The exterior issues must be made good. Environmental health professionals and structural engineers should be asked to inspect the space urgently to highlight risks we, as lay people, may have missed. This level of disrepair and neglect would not be tolerated in any workplace and is wholly unacceptable where people live. Once all this remedial work is completed the future use of the space for the benefit of VPE residents should be addressed.

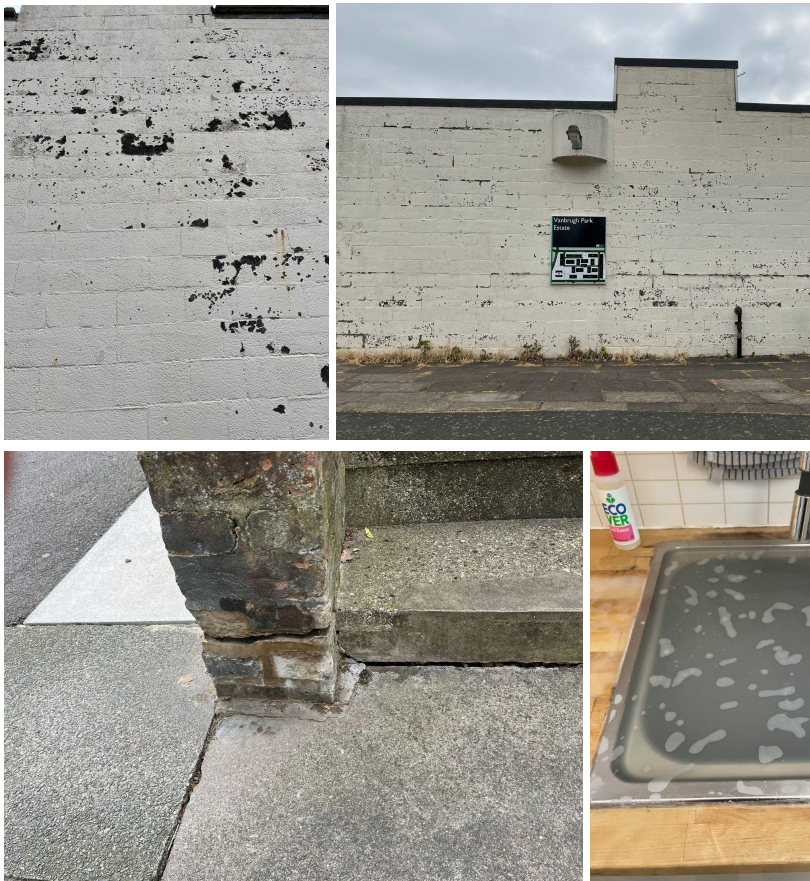
#### 1-19 Combe Mews:

*Above: Combe Mews showing deterioration of walls, subsidence effect on stairs, and overflowing sink due to blocked plumbing.*

The mews flats above the undercroft have many issues with damp including mould and mushrooms growing on walls. One resident has been unable to claim for repairs from their insurer because the insurers were able to demonstrate the damage was caused by lack of maintenance by RBG. Residents live with the constant insecurity of living above the undercroft with its hygiene, vermin, damp and structural issues and suffer both physically and mentally as a result. Drains routinely backup filling sinks etc. in the flats, one resident this week has been unable to get anyone from maintenance to

come out to their full kitchen sink. The system for logging maintenance jobs seems to be dysfunctional and where repairs are undertaken they are often done as 'patch up' jobs, masking rather than tackling the underlying problem. There are also leaks from the roof so residents have damp on both their floors and ceilings.

- The stack is fully blocked in the undercroft and will need to be entirely replaced next week. It's four or five metres long. It goes into a drain cupboard that we did not see last night and this is filled with dead pigeons.
- The plumbers advised residents to use their kitchen sinks, run the washing machine etc. over the weekend and the non-sewage waste will simply run into the open undercroft.

**Action: - remedial work in the undercroft should address many of the problems of the flats above. The drains throughout the estate are in poor repair often overflowing with sewage and should be thoroughly inspected and repair or replacement work undertaken. Residents should have a reliable and effective way of accessing repair teams when they need them. Repairs must not be done to a poor standard and only to mask existing and historic issues.**

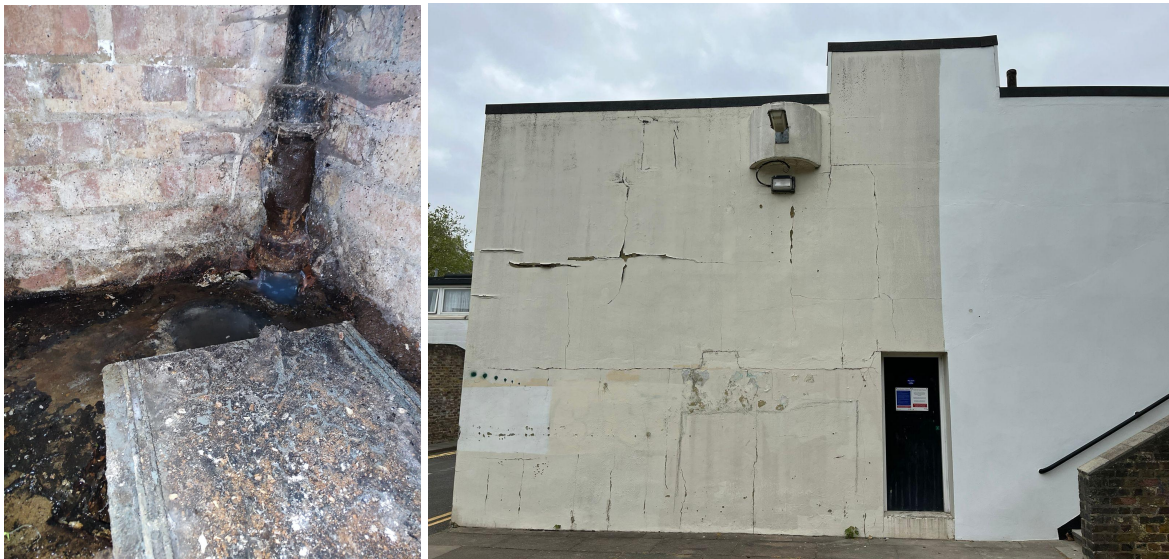
#### **9-21 Vanbrugh Park Road:**

*Above: images showing overflowing drain beneath Vanbrugh Park Road mews flats and superficial and partly finished wall repairs.*

An access stair to 9-21 Vanbrugh Park Rd has been repaired in the last 2 weeks. The cement repairs to the steps are already crumbling and the repair is not going to last. Scaffolding was in place for 3-4 weeks for this repair. The wall immediately on the staircase was painted and had superficial repairs done whilst the wall it runs into was not touched. The door to the bin store is severely damaged but was not repaired at the same time as the staircase and remains open to the elements and deteriorating.

Many garages under these flats are either empty and/or neglected. One garage has raw sewage bubbling up and others have rat infestations. We weren't able to access this garage as the door was stuck, but have included a photo taken the day before.

**Action: - repairs to be done ‘in the round’ rather than piecemeal. Materials and workmanship to be improved. Garages to be cleaned, drains repaired and subsequently let to the many residents on the estate who are on the waiting list.**

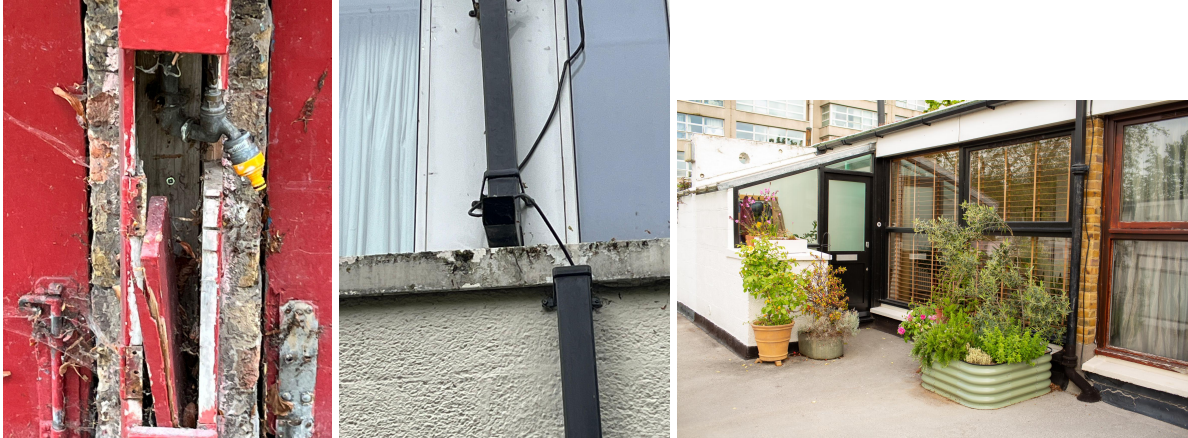
## 2-20 Combe Avenue

*Above: Broken plumbing and guttering on Combe Avenue mews flats. Outdoor space used for small front garden with clear route to front door.*

Other issues with blocked gutters and an overflowing sewer pipe at the back of 2-20 Combe Avenue and some empty garages underneath them were also highlighted.

**Action: Managed solution to maintaining access to be explored.**
